EXTERNAL STRAWBALE RENDERING

Experience – The Great Teacher

In this second instalment of a three-part series, Alan and Fiona give a blow by blow account of how they rendered the outside of their strawbale house, and how they'd do it differently if they did it again.

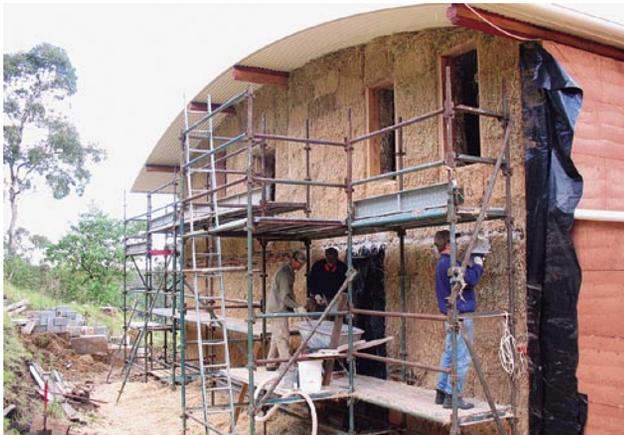
Coating timber in preparation for render.

All the timber that was to be covered with render we coated with a straw and glue mix. The render alone doesn't stick to the wood.

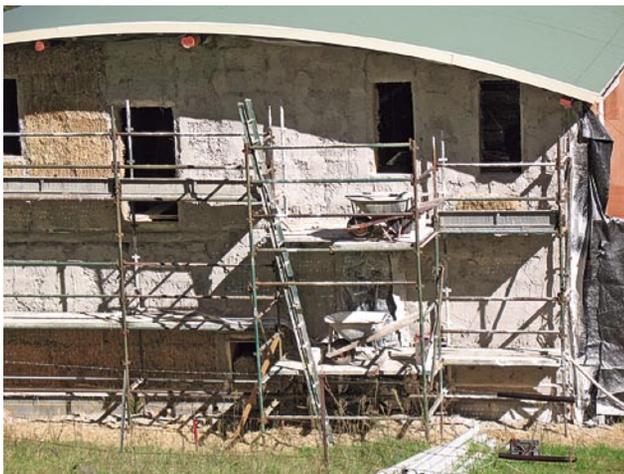
Part way through the render process.

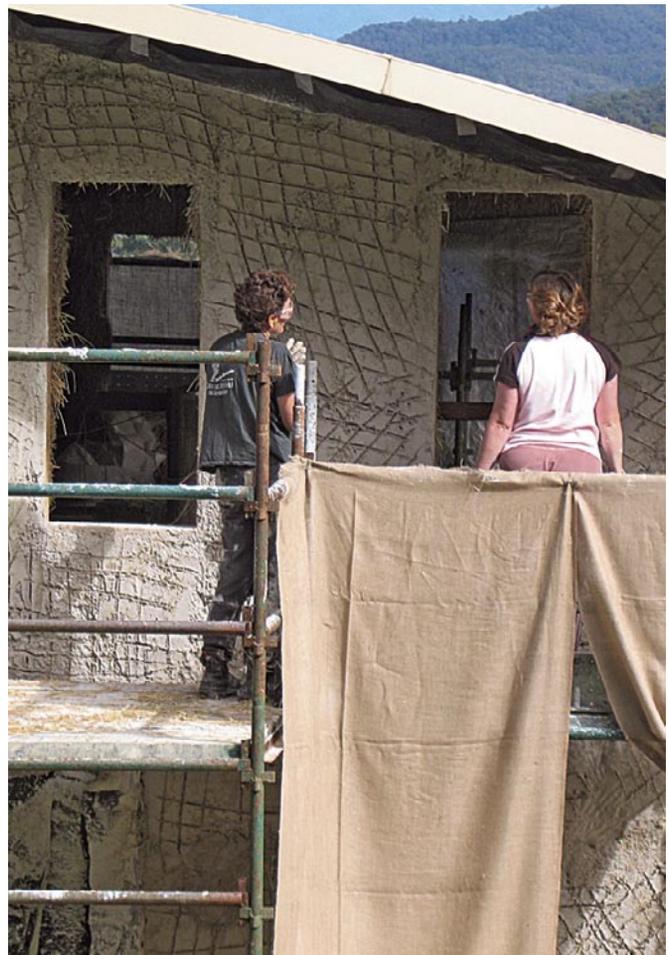
Cross-hatching the first coat.

Once the walls were all rendered we cross-hatched the surface with the pitch fork so the next layer would stick well.

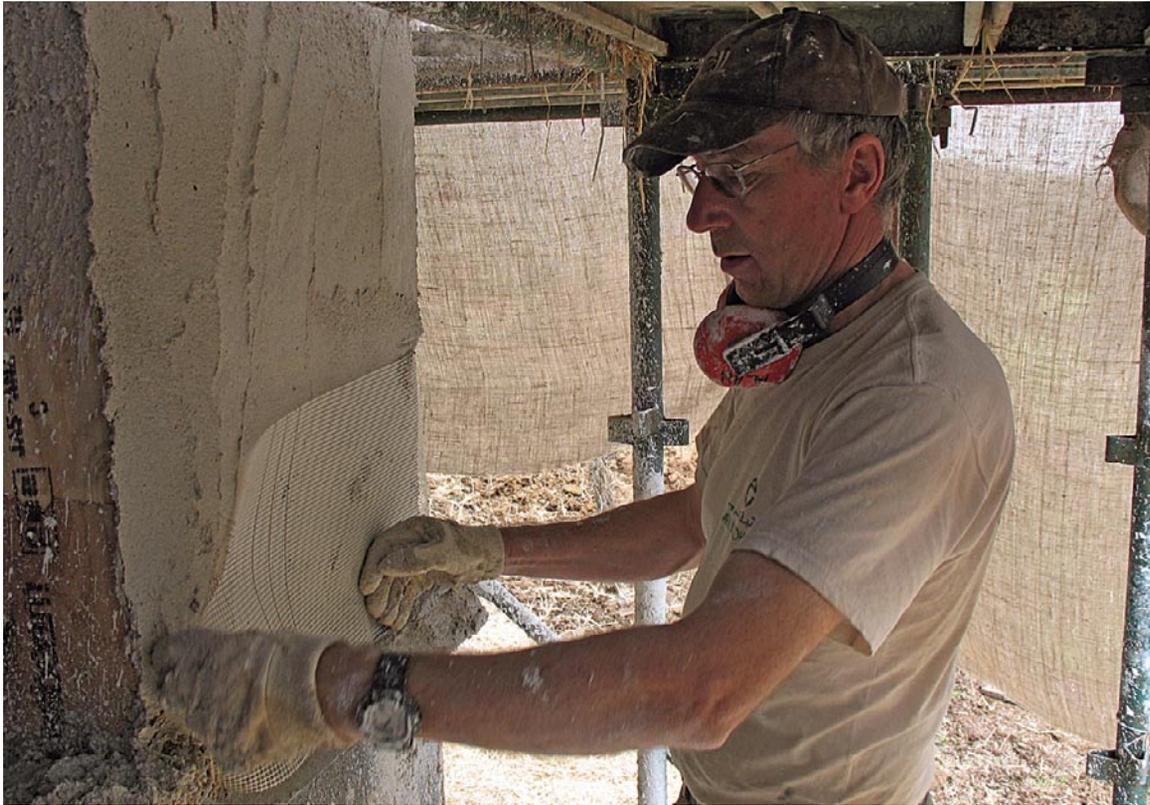
Attaching a layer of fibreglass mesh.

We placed fibreglass mesh around all openings and worked it into the render. Then we covered the whole wall with the fibreglass mesh and worked it in. The fibreglass prevents cracking and facilitates screw fixing.

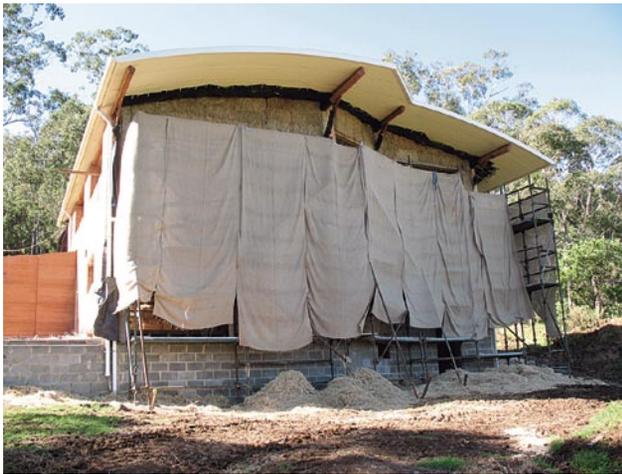
Hessian prevents the render from drying too quickly.

We hung hessian from the scaffold to shield against sun and rain. The render must be constantly wetted in the early days to allow calcification to proceed slowly.

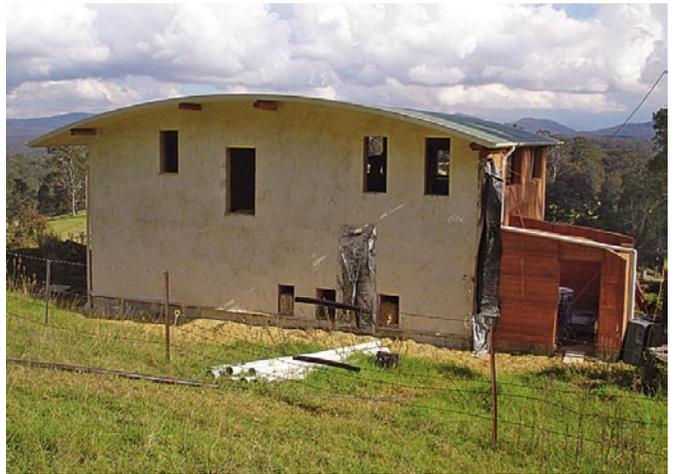
Thinner areas of render were yellowish.

We later found that we would need a further coat of render on the outside because the initial coats hadn't been thick enough in some places and the straw was too close to the surface. Frank Thomas, of Yesterday-Today-Tomorrow Straw Bale Construction, was able to tell this because some sections of the render were stained slightly yellow (from the straw). You can see this in the above picture.

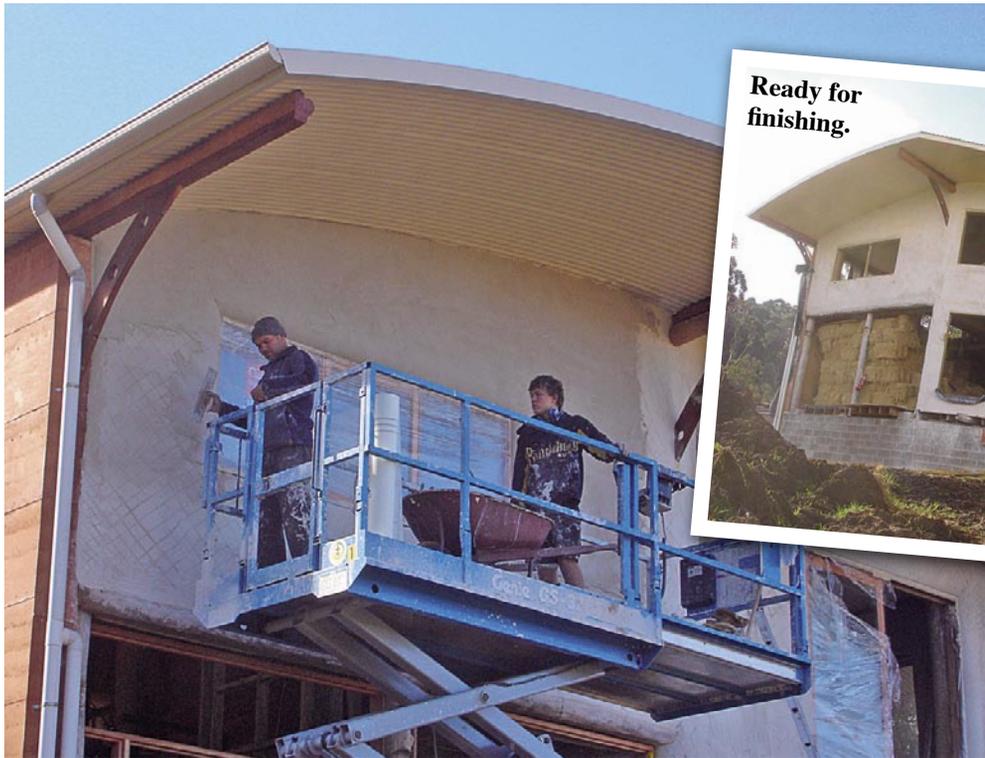
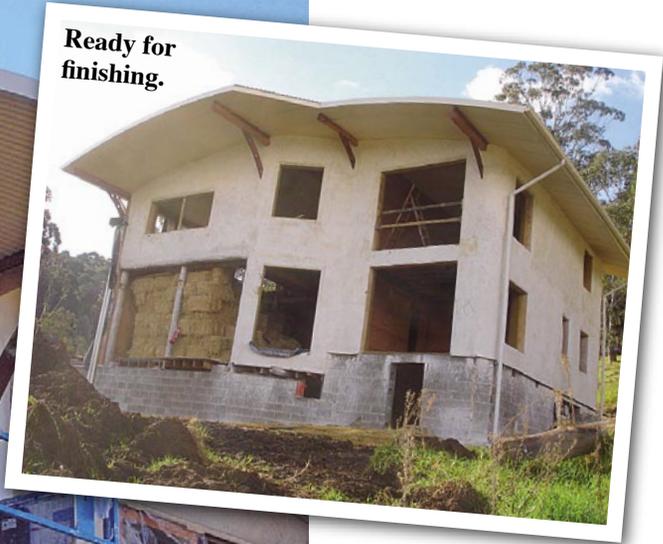
**Trowelling
the finish
coat.**

The finish coat was entirely hand applied and extensively trowelled and floated; a very labour intensive and tiring activity. The corners of openings were carefully bull-

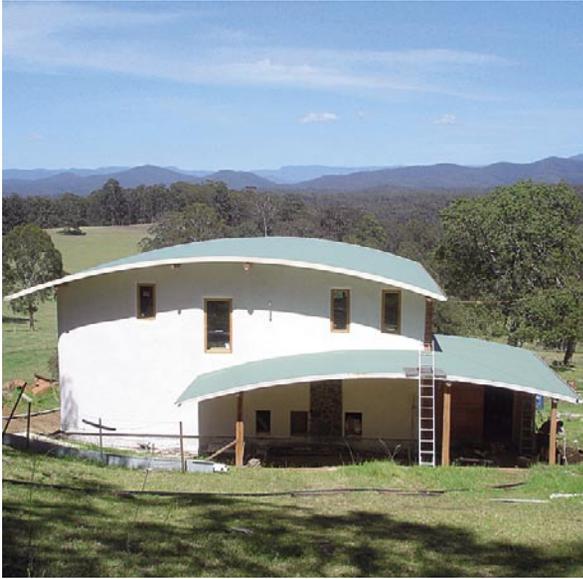
Rear view before final colouring.

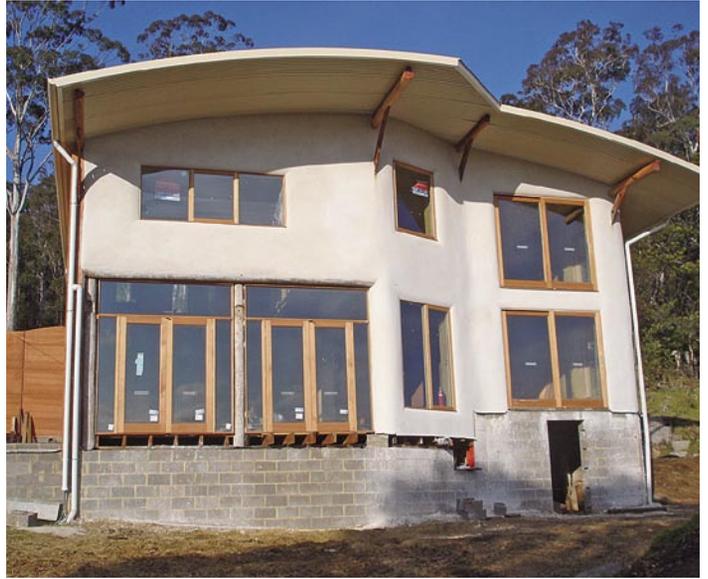
Front view showing plastic form achievable with strawbale construction.
